**Conservation of the
Dharumavantha Raasegefanu Mosque, Male'
Republic of Maldives**

**Tej Singh
Atul Kumar Yadav**

**Government of India, Ministry of Culture
National Research Laboratory for
Conservation of Cultural Property
Lucknow
(2004)**

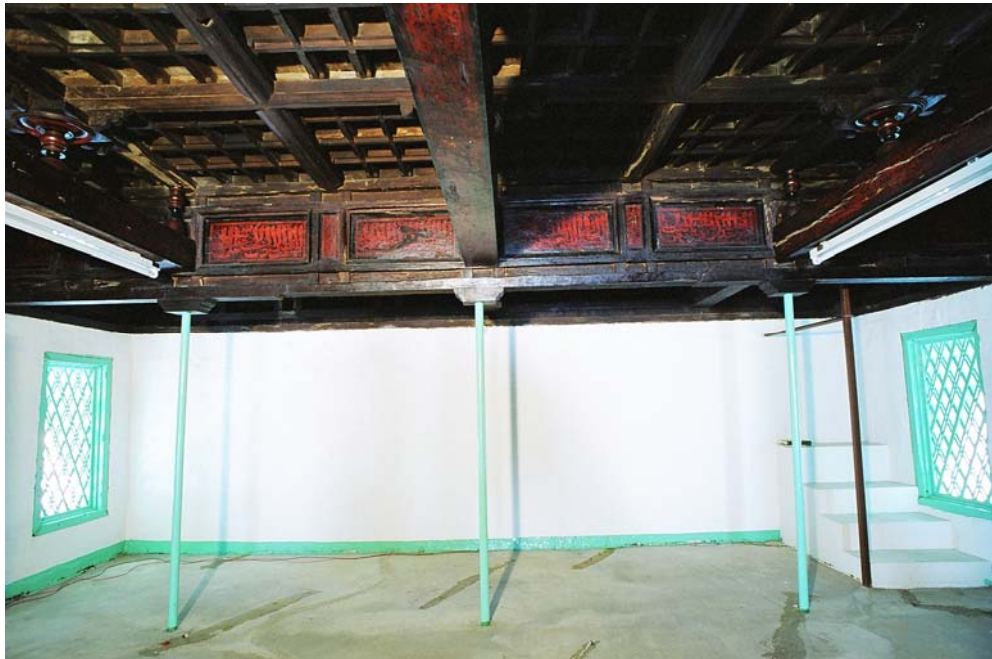
Iron Poles introduced during last Intervention

The frame of the painted panels supposedly originally placed on the inner wall at the far end of the hall was now supported on iron poles painted green with modern paint. Due to replacement of wall by iron poles, downward force per unit area had become very

high which might lead to stress failure. At the same time, the material and its green colour were not in unison with the old structure of historical importance. Wooden window frames and grills and two pillars at the outer entrance were also painted similarly. Electric lines running on the wooden beams etc. were a potential fire hazard, and tube lights were fixed directly on the beams.

13. The wall supporting the painted panels at the far end of the hall might have been decayed beyond repair, and three iron poles had been provided instead in the past to support the painted panels. The iron poles painted with modern green paint were not in unison with the monument of historical importance and the architecture of the interior of the mosque apart from the fact that downward force per unit area was also very high. Therefore, three pillars along with all their components similar to other pillars of the mosque were fabricated with seasoned wood and placed instead of iron poles.

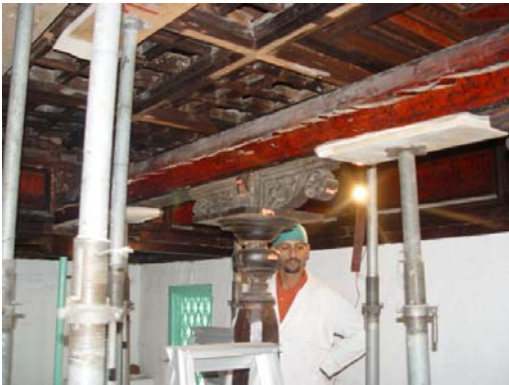
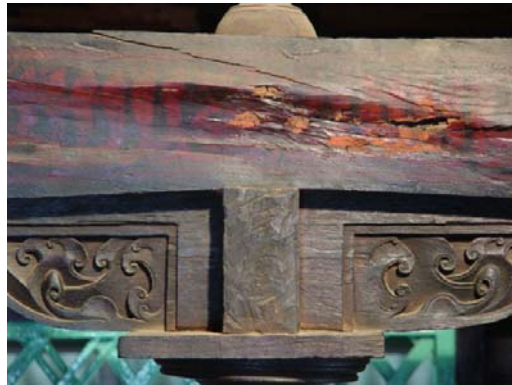
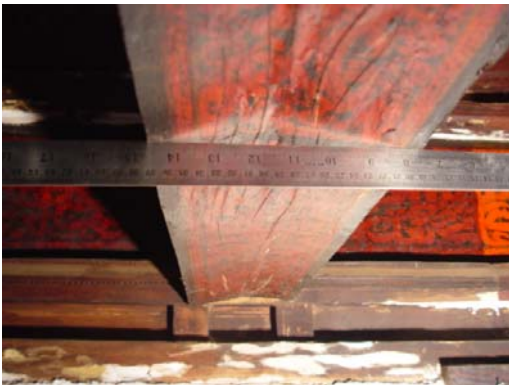
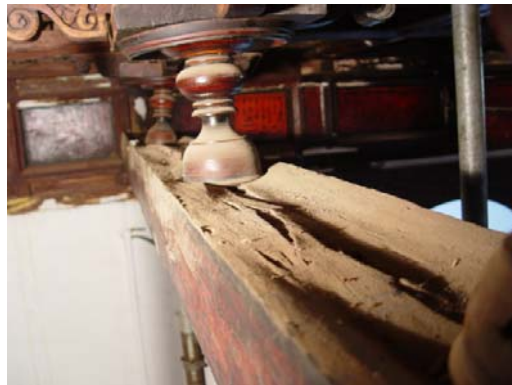
The main factor of deterioration of the mosque was insect attack. Most of the wooden members were badly eaten by insects from the inner side and only a thin outer layer was remaining there. Load bearing beams, which had become hollow, had got de-shaped and big cracks had formed on them.

Different State of Deterioration of the Beams

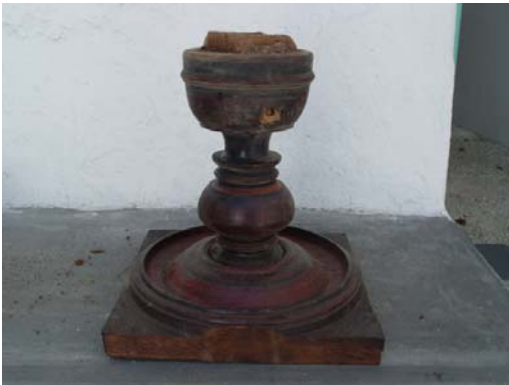
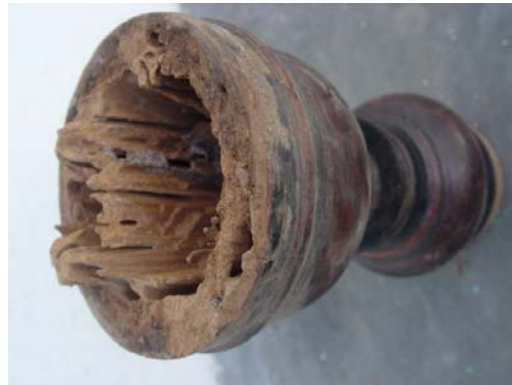
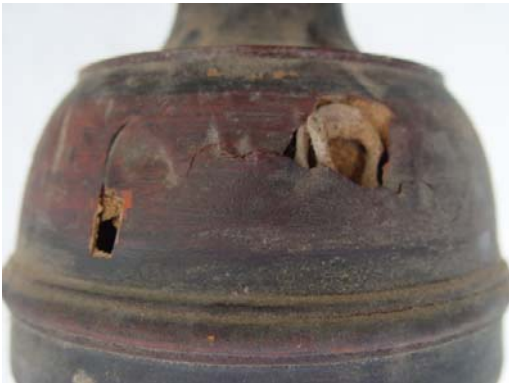
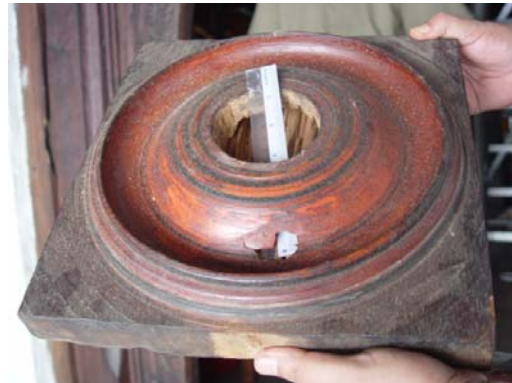
Some other components though appearing in sound condition from outside were found to be hollow after they were dismantled. Insects had generally not eaten the painted surfaces, however, paintings on some of the beams and panels were also damaged.

The Components appearing in sound condition from outside were found Hollow

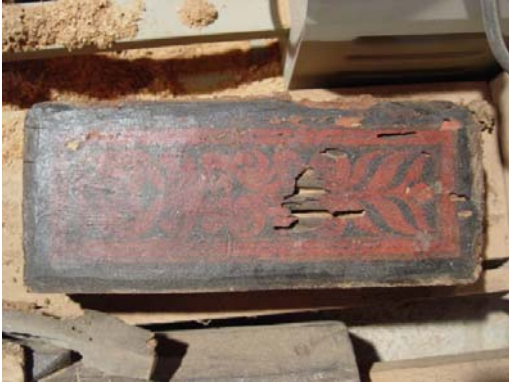
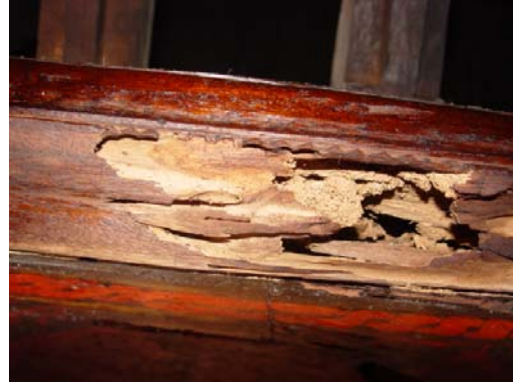
State of Conservation of some Painted Components

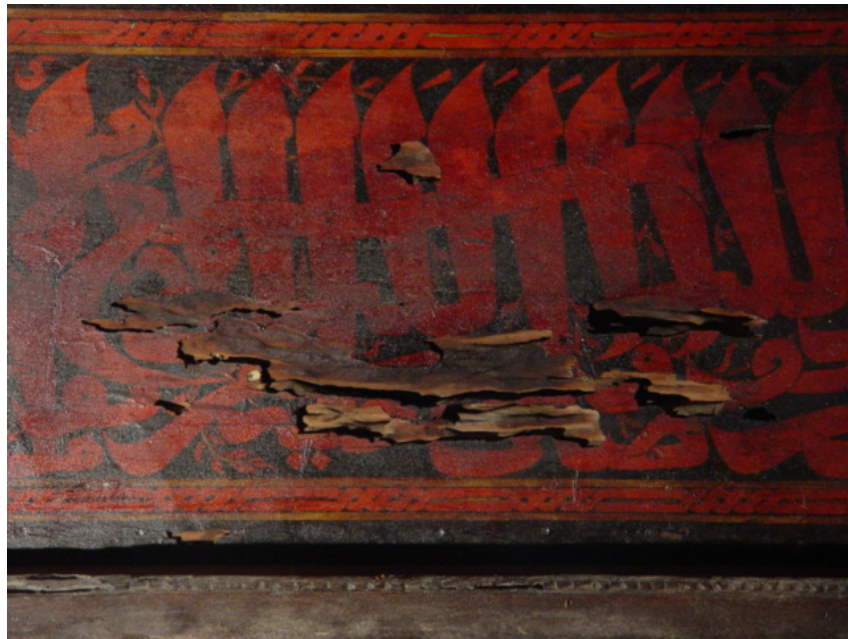
Repeated application of oil had made the paintings obscure and the bare wood blackish. Practice of burning oil lamps for illumination inside the mosque might have also contributed to the darkening of the wood surface. Paintings on the beams nearer the window on the southern side had developed chalkiness on them and had suffered extensive deterioration of the paint layer.

Paintings Obscured due to Surface Deposits

Several solvents / solvent mixtures were tested for their efficacy for cleaning. The painted areas were cleaned with 1:3 alcohol and turpentine mixture, and the bare wood was cleaned with 1:1 mixture of the same reagents. Wooden window grills and two pillars in the front corridor were painted with several layers of modern paint. Bulk of the paint was removed with a commercial paint stripper, and final layer was removed with 1:1 alcohol and turpentine mixture. The white patches of putty used for consolidation were reintegrated, and finally a protective coating of picture varnish was given.
