**Conservation of the
Dharumavantha Raasegefanu Mosque, Male'
Republic of Maldives**

**Tej Singh
Atul Kumar Yadav**

**Government of India, Ministry of Culture
National Research Laboratory for
Conservation of Cultural Property
Lucknow
(2004)**

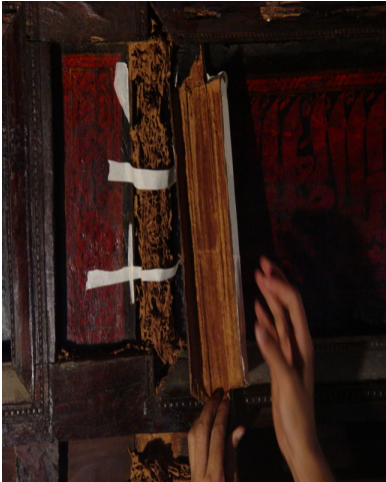
Consolidation of Vertical Frames

First of all, the painted panels, frames of the painted panels and rafters were consolidated with sawdust and PVA putty and final layer was that of PVA emulsion and whiting so that its texture matched with that of wood and it also received well the earth colours used for reintegration. The missing elements were reconstructed to make them to bear the load of the structure.

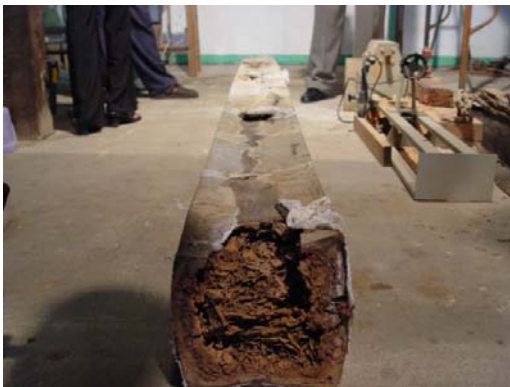
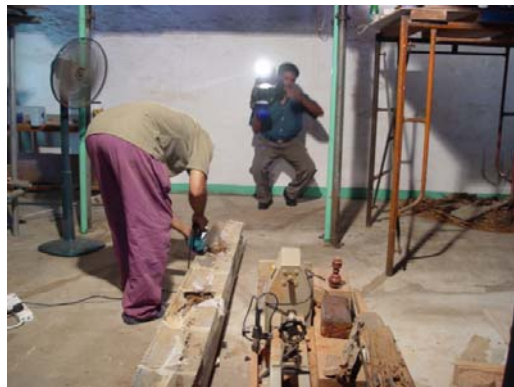
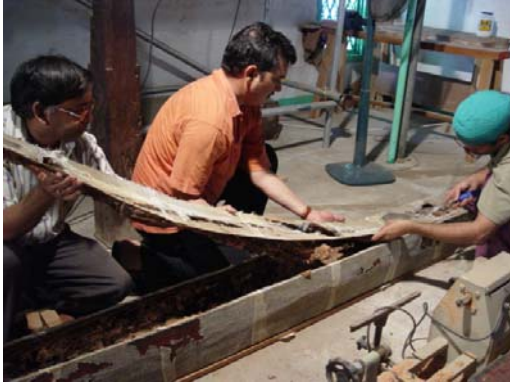
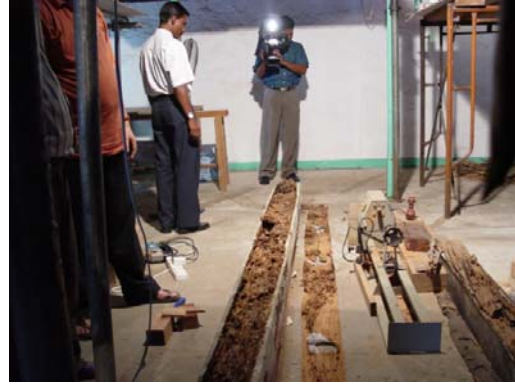
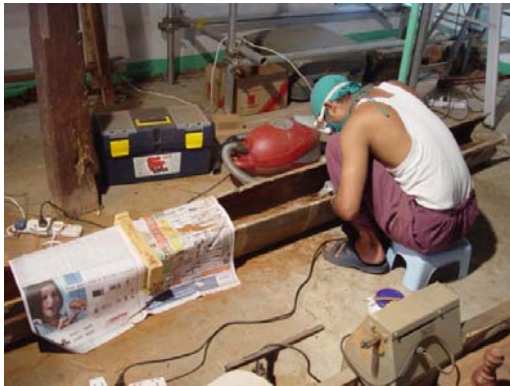
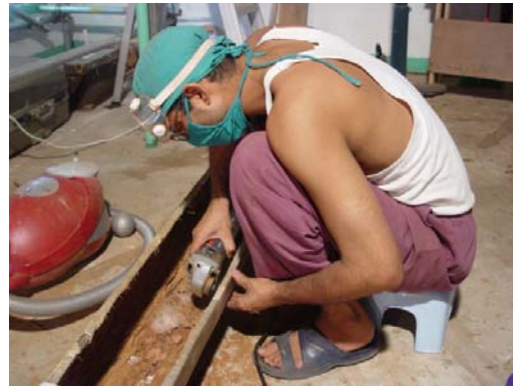
4. The beam was further evenly supported by inserting a sturdy wooden plank between the beam and the jacks, and the beam was lifted up till it was free on both the sides. The beam was then tilted and taken down. The beam was found to be hollow. The top layer of the beam was cut along the cracks. The beam was cleaned of debris. The beam was consolidated from inside with sawdust and polyvinyl acetate (PVA) emulsion, and then the inner side was made even with angular grinder.

5. A new beam of locally available hard wood was made. The thickness of the new beam was such that it was just fitting the gap in the old beam and its length was bigger than the old beam. Slurry of PVA emulsion and sawdust was coated inside of the old beam, and PVA emulsion was applied on the new beam. While the PVA was still wet, the new beam was placed inside the old beam keeping the extra length of the new beam projecting equally on both the sides. The beam was clamped
